## Delta Wide Crevasses (MR-09)

**Project Type:** Water Diversion

The project consists of maintaining presently existing crevasse splays, the construction of new crevasse splays and plugs, and future maintenance of selected crevasse splays in both the Pass a Loutre Wildlife Management Area and the Delta National Wildlife Refuge. The objective is to promote the formation of emergent freshwater and intermediate marsh.

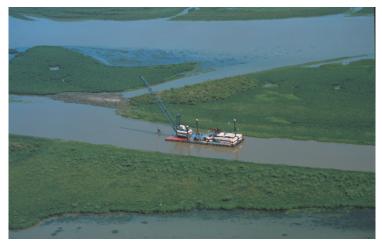
This image shows a crevasse being plugged in 1999 in order to maximize the effectiveness of crevasses downstream. As this project contains several building cycles, project components are adjusted over time to achieve optimal performance as new features are constructed.
